**Flood Control Project Maintenance
Levee Inspections**

Fall 2012 Levee Maintenance Deficiency Summary Report

Reclamation District No. 0536 Egbert

Levee Inspection Report By Mile - Fall 2012

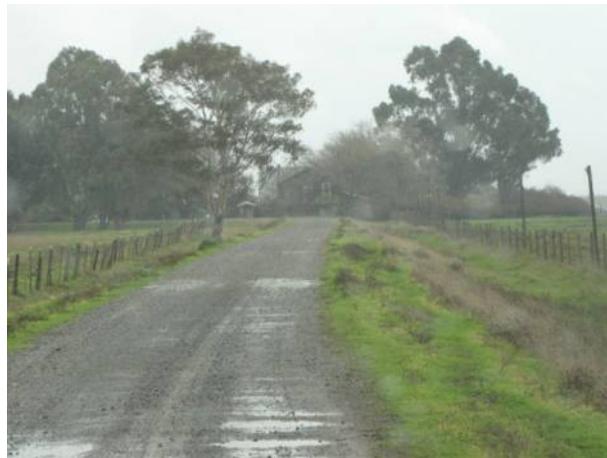
Levee Mile Report Line	4
Start Levee Mile	0.00
End Levee Mile	0.00
Location	Land Side
Category	Earthen Levee
Item	Vegetation
RD 536 Unit 1 Looking downstream from levee mile 0.00. Photo taken 11-28-2012.	
phillips_f_20121206_466.jpg

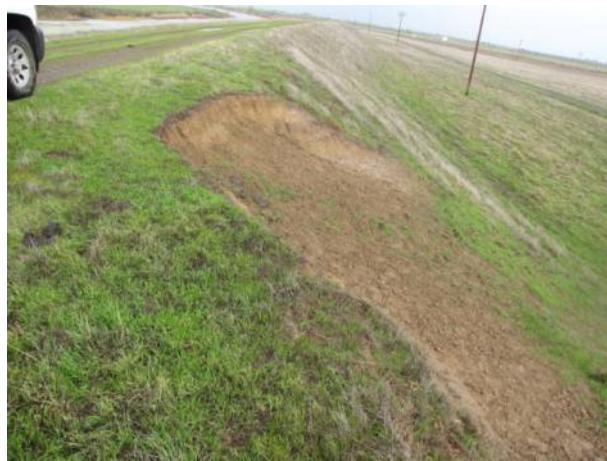
Levee Mile Report Line	9
Start Levee Mile	0.74
End Levee Mile	0.75
Location	Land Side
Category	Earthen Levee
Item	Erosion / Bank Caving
This erosion was noted in prior inspections during the spring of 2011 and the spring of 2012. Photo taken 11-28-2012.	
phillips_f_20121206_471.jpg

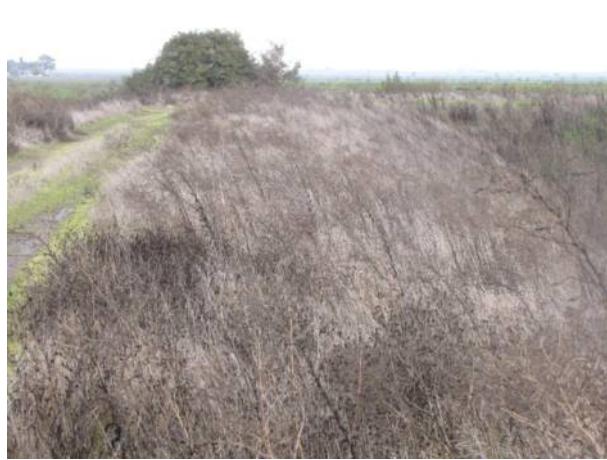
Levee Mile Report Line	15
Start Levee Mile	1.76
End Levee Mile	3.67
Location	Land Side
Category	Earthen Levee
Item	Vegetation
RD 536 Unit 1, unsatisfactory growth on the landside. Photo taken 11-28-2012.	
phillips_f_20121206_467.jpg

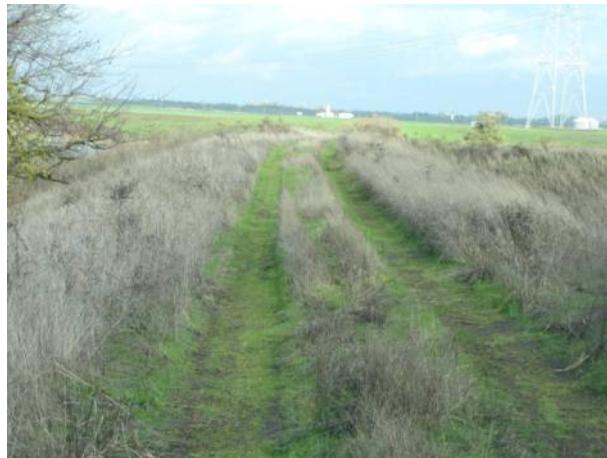
Levee Mile Report Line	21
Start Levee Mile	2.75
End Levee Mile	4.65
Location	Crown
Category	Earthen Levee
Item	Crown Surface / Depressions / Rutting
RD 536, unsatisfactory growth on the crown. The crown should be free of grasses. Photo taken 11-28-2012.	
phillips_f_20121206_472.jpg

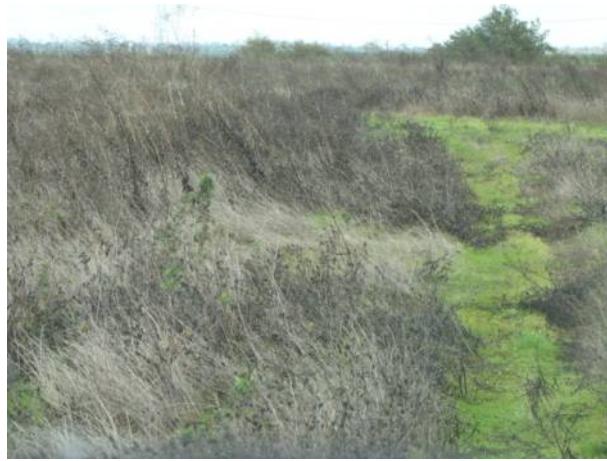
Levee Mile Report Line	23
Start Levee Mile	3.38
End Levee Mile	3.77
Location	Water Side
Category	Earthen Levee
Item	Vegetation
RD 536, wild growth on waterside of levee section, can't see the slope. Photo taken 11-28-2012.	
phillips_f_20121206_473.jpg

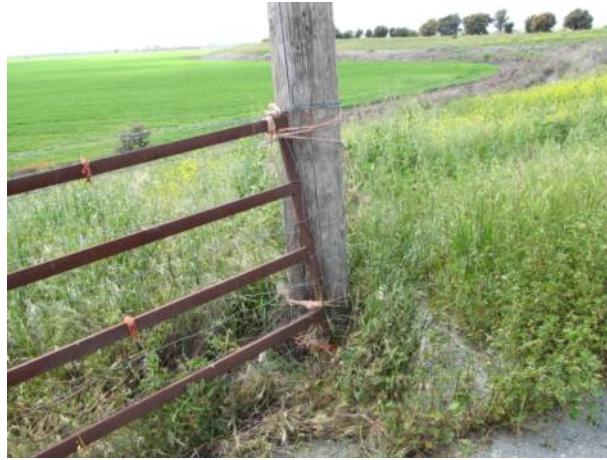
Levee Mile Report Line	25
Start Levee Mile	3.68
End Levee Mile	3.68
Location	Crown
Category	Earthen Levee
Item	Repair Gates
Repair this gate. Someone could get hurt trying to open and close this gate. 4-24-2012.	
phillips_f_20120911_211.jpg

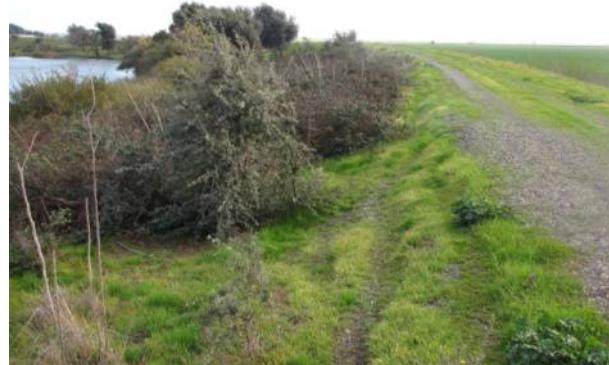
Levee Mile Report Line	28
Start Levee Mile	4.20
End Levee Mile	4.61
Location	Water Side
Category	Earthen Levee
Item	Vegetation
RD 536, wild growth waterside. Photo taken 11-28-2012.	
phillips_f_20121206_468.jpg

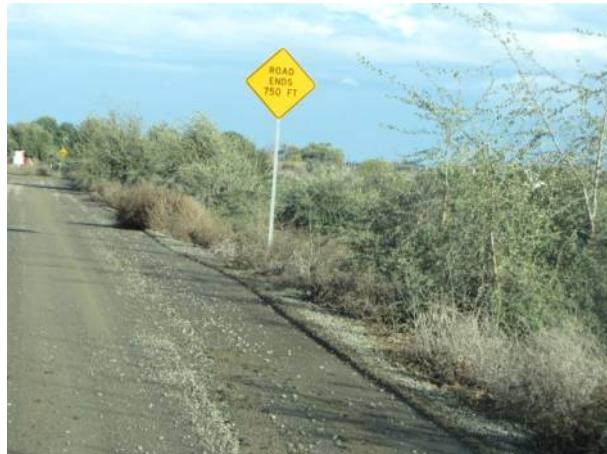
Levee Mile Report Line	35
Start Levee Mile	5.17
End Levee Mile	5.59
Location	Land Side
Category	Earthen Levee
Item	Vegetation

RD 536, wild wooded growth landside slope.
Photo taken 11-28-2012.

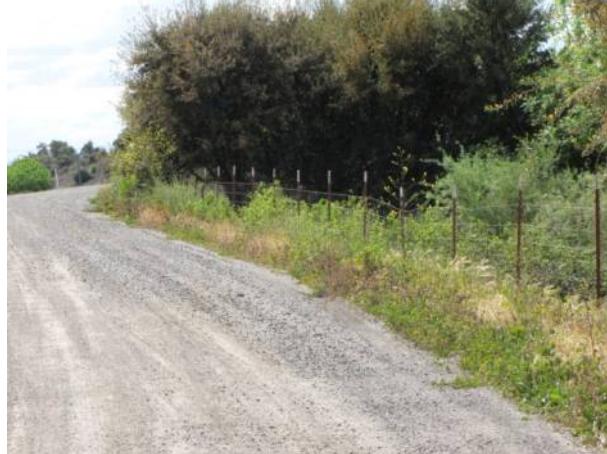
Levee Mile Report Line	36
Start Levee Mile	5.19
End Levee Mile	5.46
Location	Water Side
Category	Earthen Levee
Item	Vegetation
Overgrown slope waterward along levee mile 5.19-5.46. Photo taken 4-24-2012.	
phillips_f_20120911_203.jpg

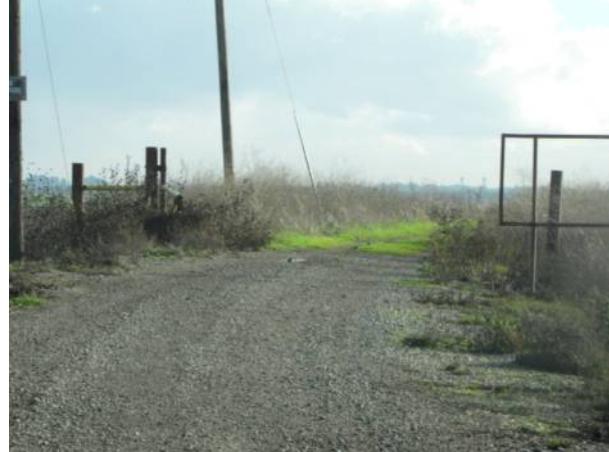
Levee Mile Report Line	1
Start Levee Mile	0.00
End Levee Mile	0.00
Location	Land Side
Category	Earthen Levee
Item	Vegetation
RD 536 Unit 2 looking downstream from levee mile 0.00. Photo taken 11-28-2012.	
phillips_f_20121206_476.jpg

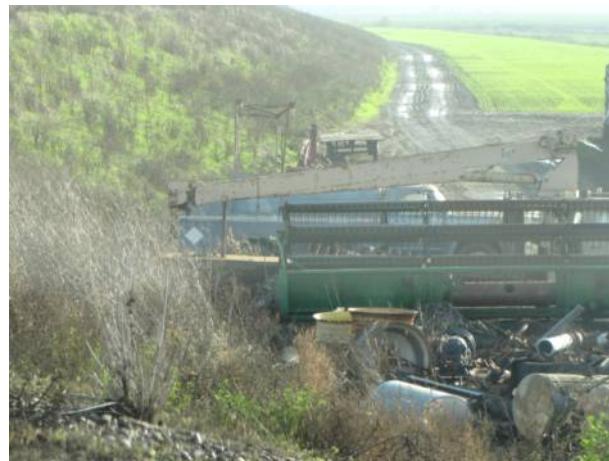
Levee Mile Report Line	2
Start Levee Mile	0.01
End Levee Mile	0.06
Location	Land Side
Category	Earthen Levee
Item	Encroachments
Unauthorized encroachment landside. Photo taken 11-28-2012.	
phillips_f_20121206_477.jpg

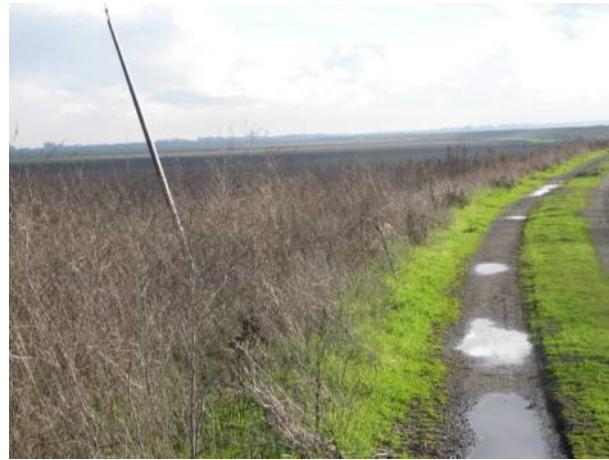
Levee Mile Report Line	3
Start Levee Mile	0.01
End Levee Mile	4.91
Location	Water Side
Category	Earthen Levee
Item	Vegetation
RD 536, wild growth on waterside looking downstream. Photo taken 11-28-2012.	
phillips_f_20121206_474.jpg

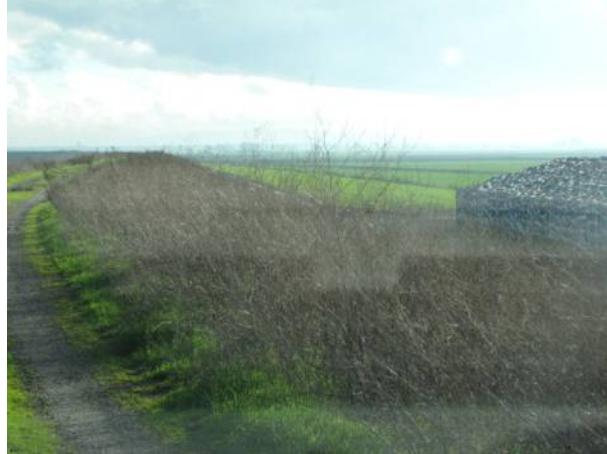
Levee Mile Report Line	4
Start Levee Mile	0.03
End Levee Mile	4.91
Location	Land Side
Category	Earthen Levee
Item	Vegetation
RD 536, wild growth on landward shoulder and slope, can't see the levee section. Photo taken 11-28-2012.	
phillips_f_20121206_475.jpg

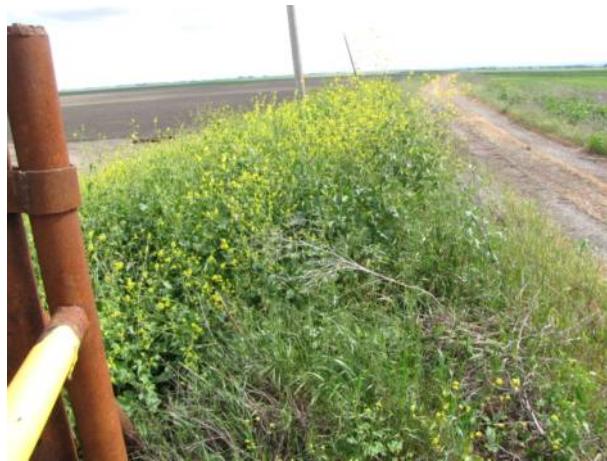
Levee Mile Report Line	5
Start Levee Mile	0.04
End Levee Mile	0.10
Location	Water Side
Category	Earthen Levee
Item	Vegetation
Looking downstream at the waterside shoulder and slope. Photo taken 4-24-2012.	
phillips_f_20120911_216.jpg

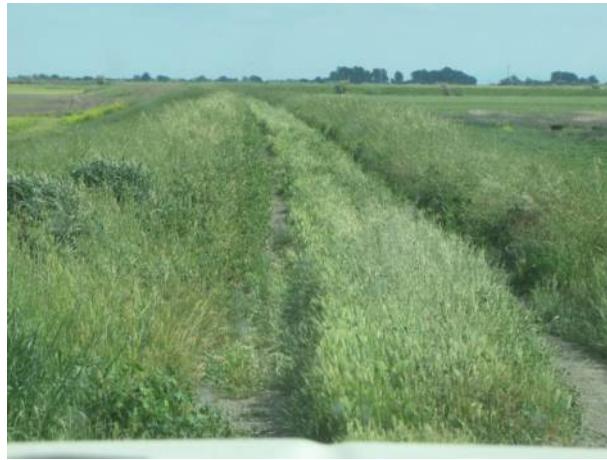
Levee Mile Report Line	13
Start Levee Mile	2.22
End Levee Mile	2.98
Location	Crown
Category	Earthen Levee
Item	Crown Surface / Depressions / Rutting
Looking downstream along levee mile 2.22-2.95 at the crown roadway. Photo taken 4-24-2012.	
phillips_f_20120911_219.jpg
